**Re: Concrete Floor Slab
Lebanon Fire Department – Lebanon, ME
TFM Project #: 47197.00**

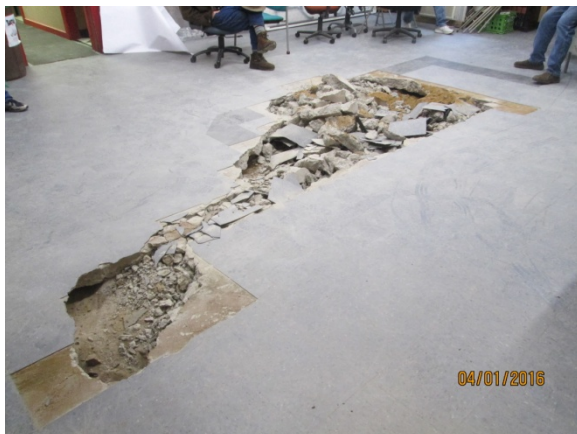
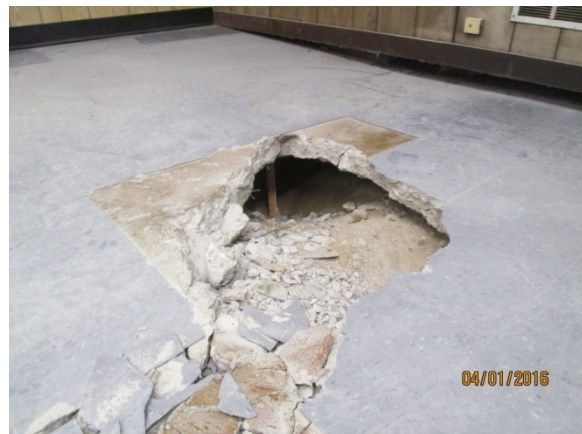
The building itself is approximately 40 years old constructed of Concrete Masonry Unit (CMU) blocks with clear spanning wood trusses. In general, the slab within the meeting room has settled significantly, causing cracks and complete collapse above sub-slab voids. It is our understanding that the settlement has occurred over the past 5 to 7 years. Sections of the meeting room slab have been partially removed exposing the soil conditions below. TFM measured a void below the slab of approximately 12", and a differential settlement of approximately 6" compared to a point along the exterior wall. The exterior CMU walls did not show any signs of cracking or settlement. TFM also investigated the minor slab cracking that is present within the apparatus bay. Soil conditions themselves were not investigated. The following photos depict the current conditions within the meeting room:

Based on our observations, it is our opinion that the soil sub-slab conditions are poor and have settled over time. It appears as though the settlement is limited to the areas observed, and has not impacted the overall stability of the building's superstructure (walls and roof). The extent of the settlement below the slab and whether or not the soil will continue to settlement is an unknown at this time. Because of the severity of the settlement and damage to the meeting room slab, repair recommendations are as follows:

1. Remove existing slab within the meeting room. Slabs within the kitchen and mechanical room can remain unless additional voids are found to exist after the removal of the meeting room slab.

2. Engage geotechnical engineer to investigate and evaluate the soil sub-slab conditions to determine if soils will continue to settle in the future. Depending on the results of this investigation, the following repair solutions may be appropriate:

- a. If soils are stable, properly compact and provide new structural fill up to underside of floor slab. Install vapor barrier and new 4" minimum concrete slab on grade reinforced with a steel wire mesh. Dowel new slab into existing slab at saw cut edges.

- b. If soils are unstable to a shallow depth, remove existing soils and replace with new structural fill up to the underside of floor slab. Install vapor barrier and new 4" minimum concrete slab on grade reinforced with a steel wire mesh. Dowel new slab into existing slab at saw cut edges.

- c. If soils are unstable below the bottom of existing exterior wall foundations, install steel shaft helical piles drilled down into proper subgrade (depth to be determined by geotechnical engineer and pile supplier). After pile installation, install vapor barrier and 6" minimum reinforced concrete slab spanning between piles. Dowel new slab into existing slab at saw cut edges.
