STRUCTURAL ASSESSMENT REPORT
LEBANON FIRE STATIONS
1524 CARL BROGGI HIGHWAY & 113 DEPOT ROAD
LEBANON, MAINE

March 31, 2020

Project #2020-027

**Re: Lebanon Fire Stations, Lebanon ME
Structural Assessment Report
HEB Project #2020-027**

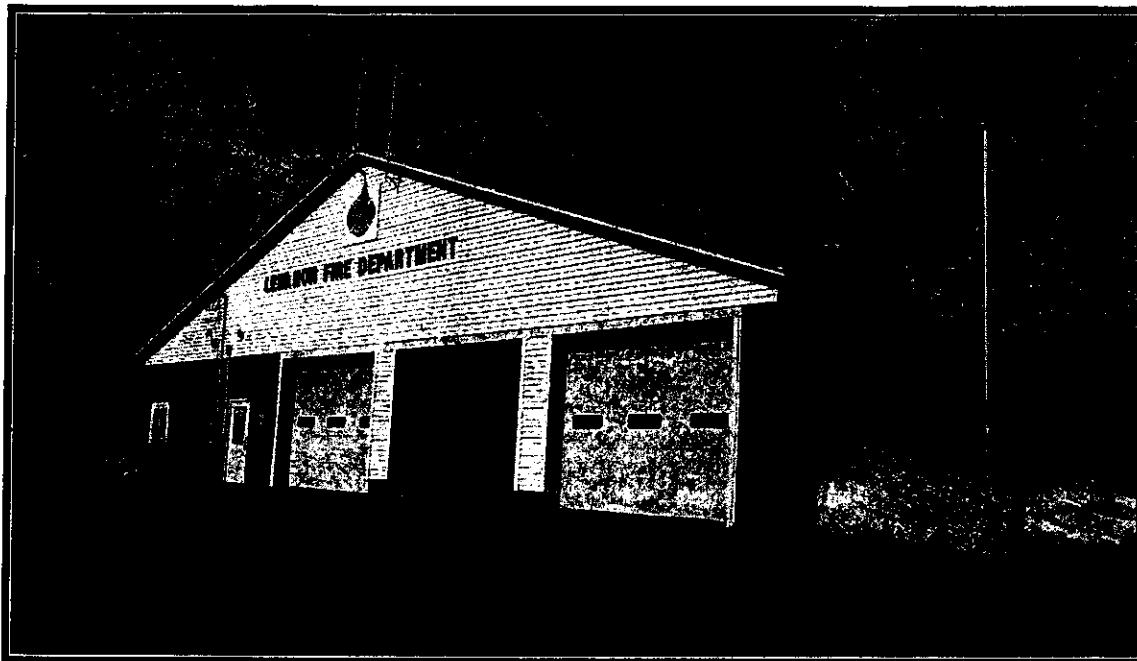
The existing single-story, concrete masonry unit (CMU), and wood-framed building is approximately 65 feet wide and 60 feet deep. There are three (3) overhead garage doors and one (1) standard entry door along the front (southern side) of the building (see Photo 7). The building houses several fire trucks and emergency vehicles along with storage rooms, a kitchen, and offices all of which are no longer being used. Roger Hooper reported that the rear portion of the building has been condemned due to some significant settling of the floor slab.

Photo 7: 113 Depot Road – Front of building.

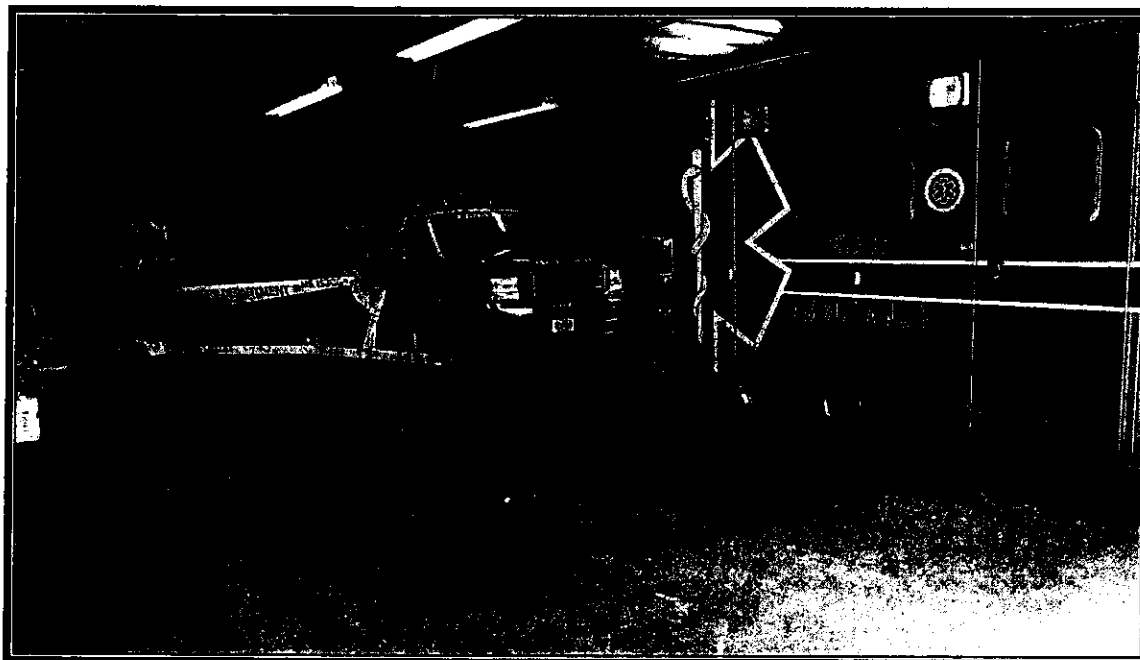
Photo 8: 113 Depot Road – Trench drain in slab.
