Engineering Study

Townhouse Road and New Bridge Road over Northeast Pond

Milton-Lebanon 40658

NHDOT Bridge No. 168/151

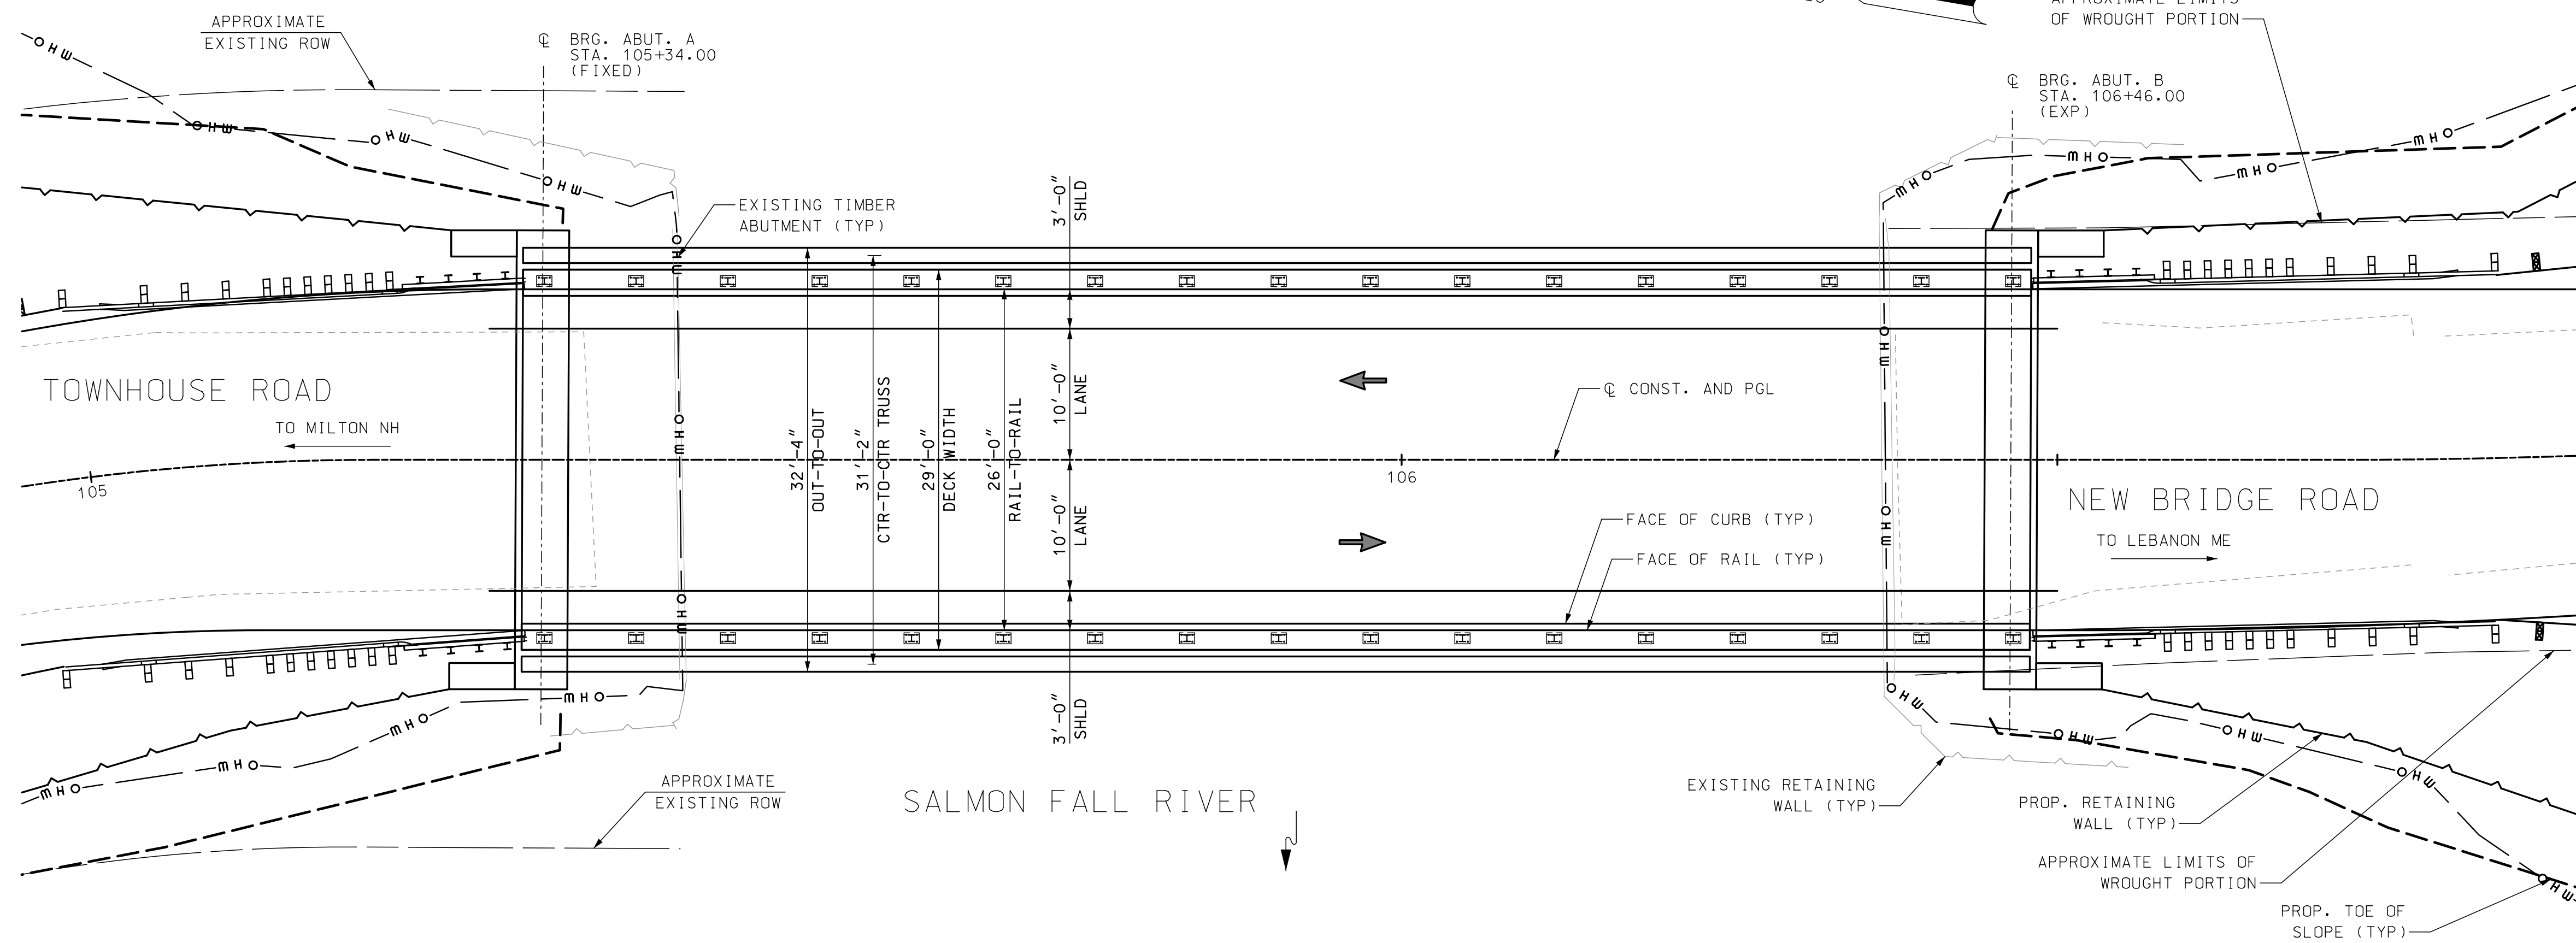
PROPOSED PLAN

Alternative 1 proposes a bridge with a prefabricated steel pony truss superstructure with a concrete deck and integral wearing surface. The bridge would consist of a single 112'-0" span (center to center of bearing). The truss would be designed and delivered by a fabricator under contract to the selected contractor.

The proposed superstructure would consist of a 29'-0" wide x 9" thick composite cement concrete deck with integral wearing surface and supported by a stringer and floor beam system with a Warren style pony truss configuration. The superstructure would be 32'-4" wide out-to-out and approximately 36.5" deep measured from center of roadway crown to bottom of truss chord. All steel components would be galvanized.

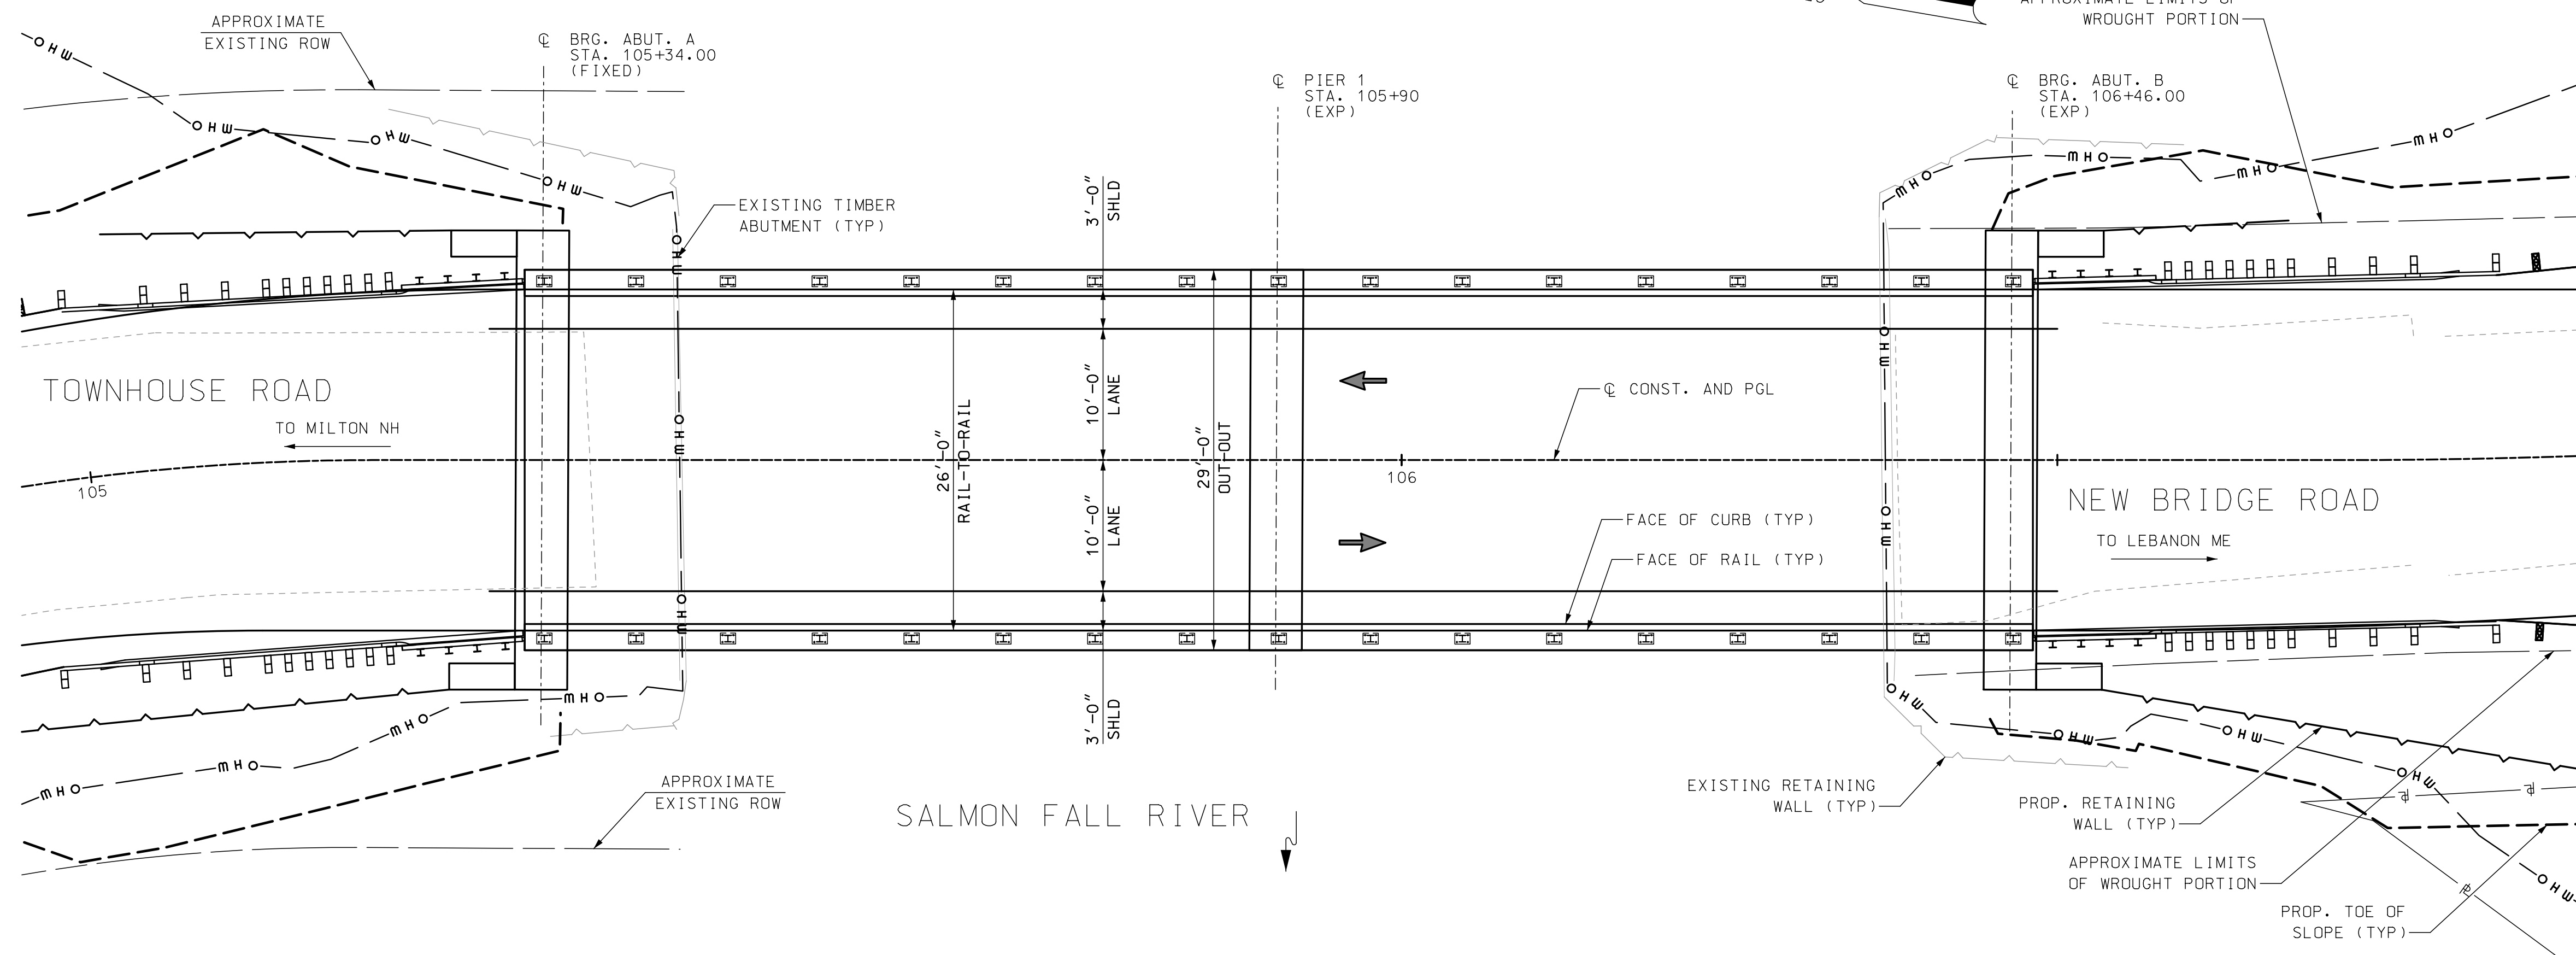
PROPOSED PLAN

Alternative 2 proposes a two-span bridge consisting of a press brake formed steel tub girders with a concrete deck and integral wearing surface. The bridge would consist of two equal spans totaling 112'-0" (center to center of abutment bearing).

The proposed superstructure would consist of a 29'-0" wide (out-to-out) x 9" thick composite cement concrete deck with integral wearing surface and supported by 18" deep press brake formed tub girders. The superstructure would consist of the thin steel plate tubs press brake formed into a tub shape with both internal and external steel bracing and will be approximately 32" deep measured from center of roadway crown to bottom of exterior girder. All steel

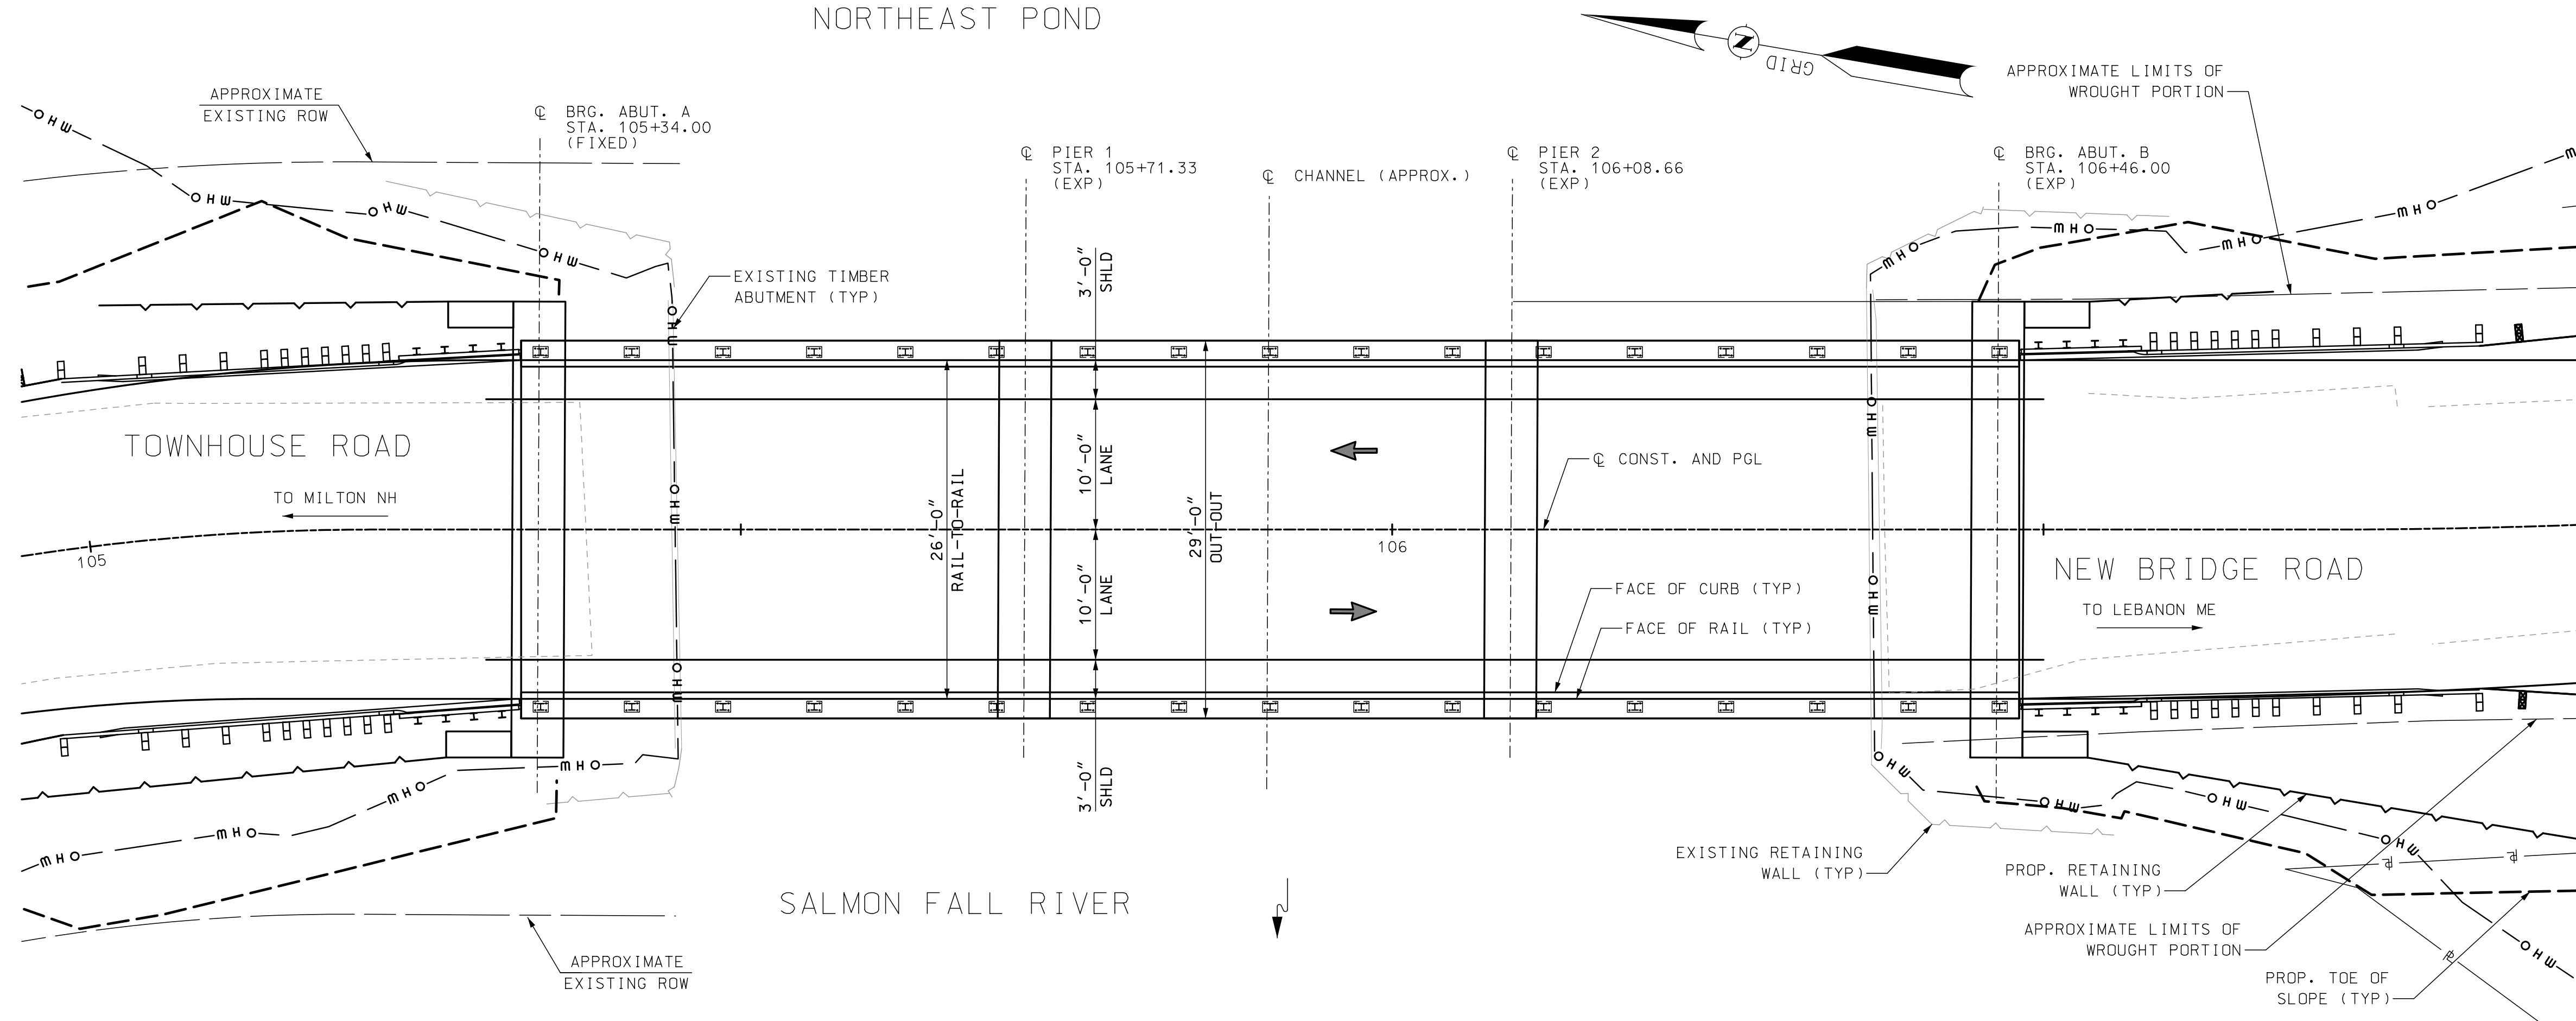
PROPOSED PLAN

Alternative 3 proposes a three-span bridge consisting of butted precast prestressed deck beams with a concrete overlay and bituminous concrete wearing surface. The bridge would consist of three equal spans totaling 112'-0" (center to center of abutment bearing).

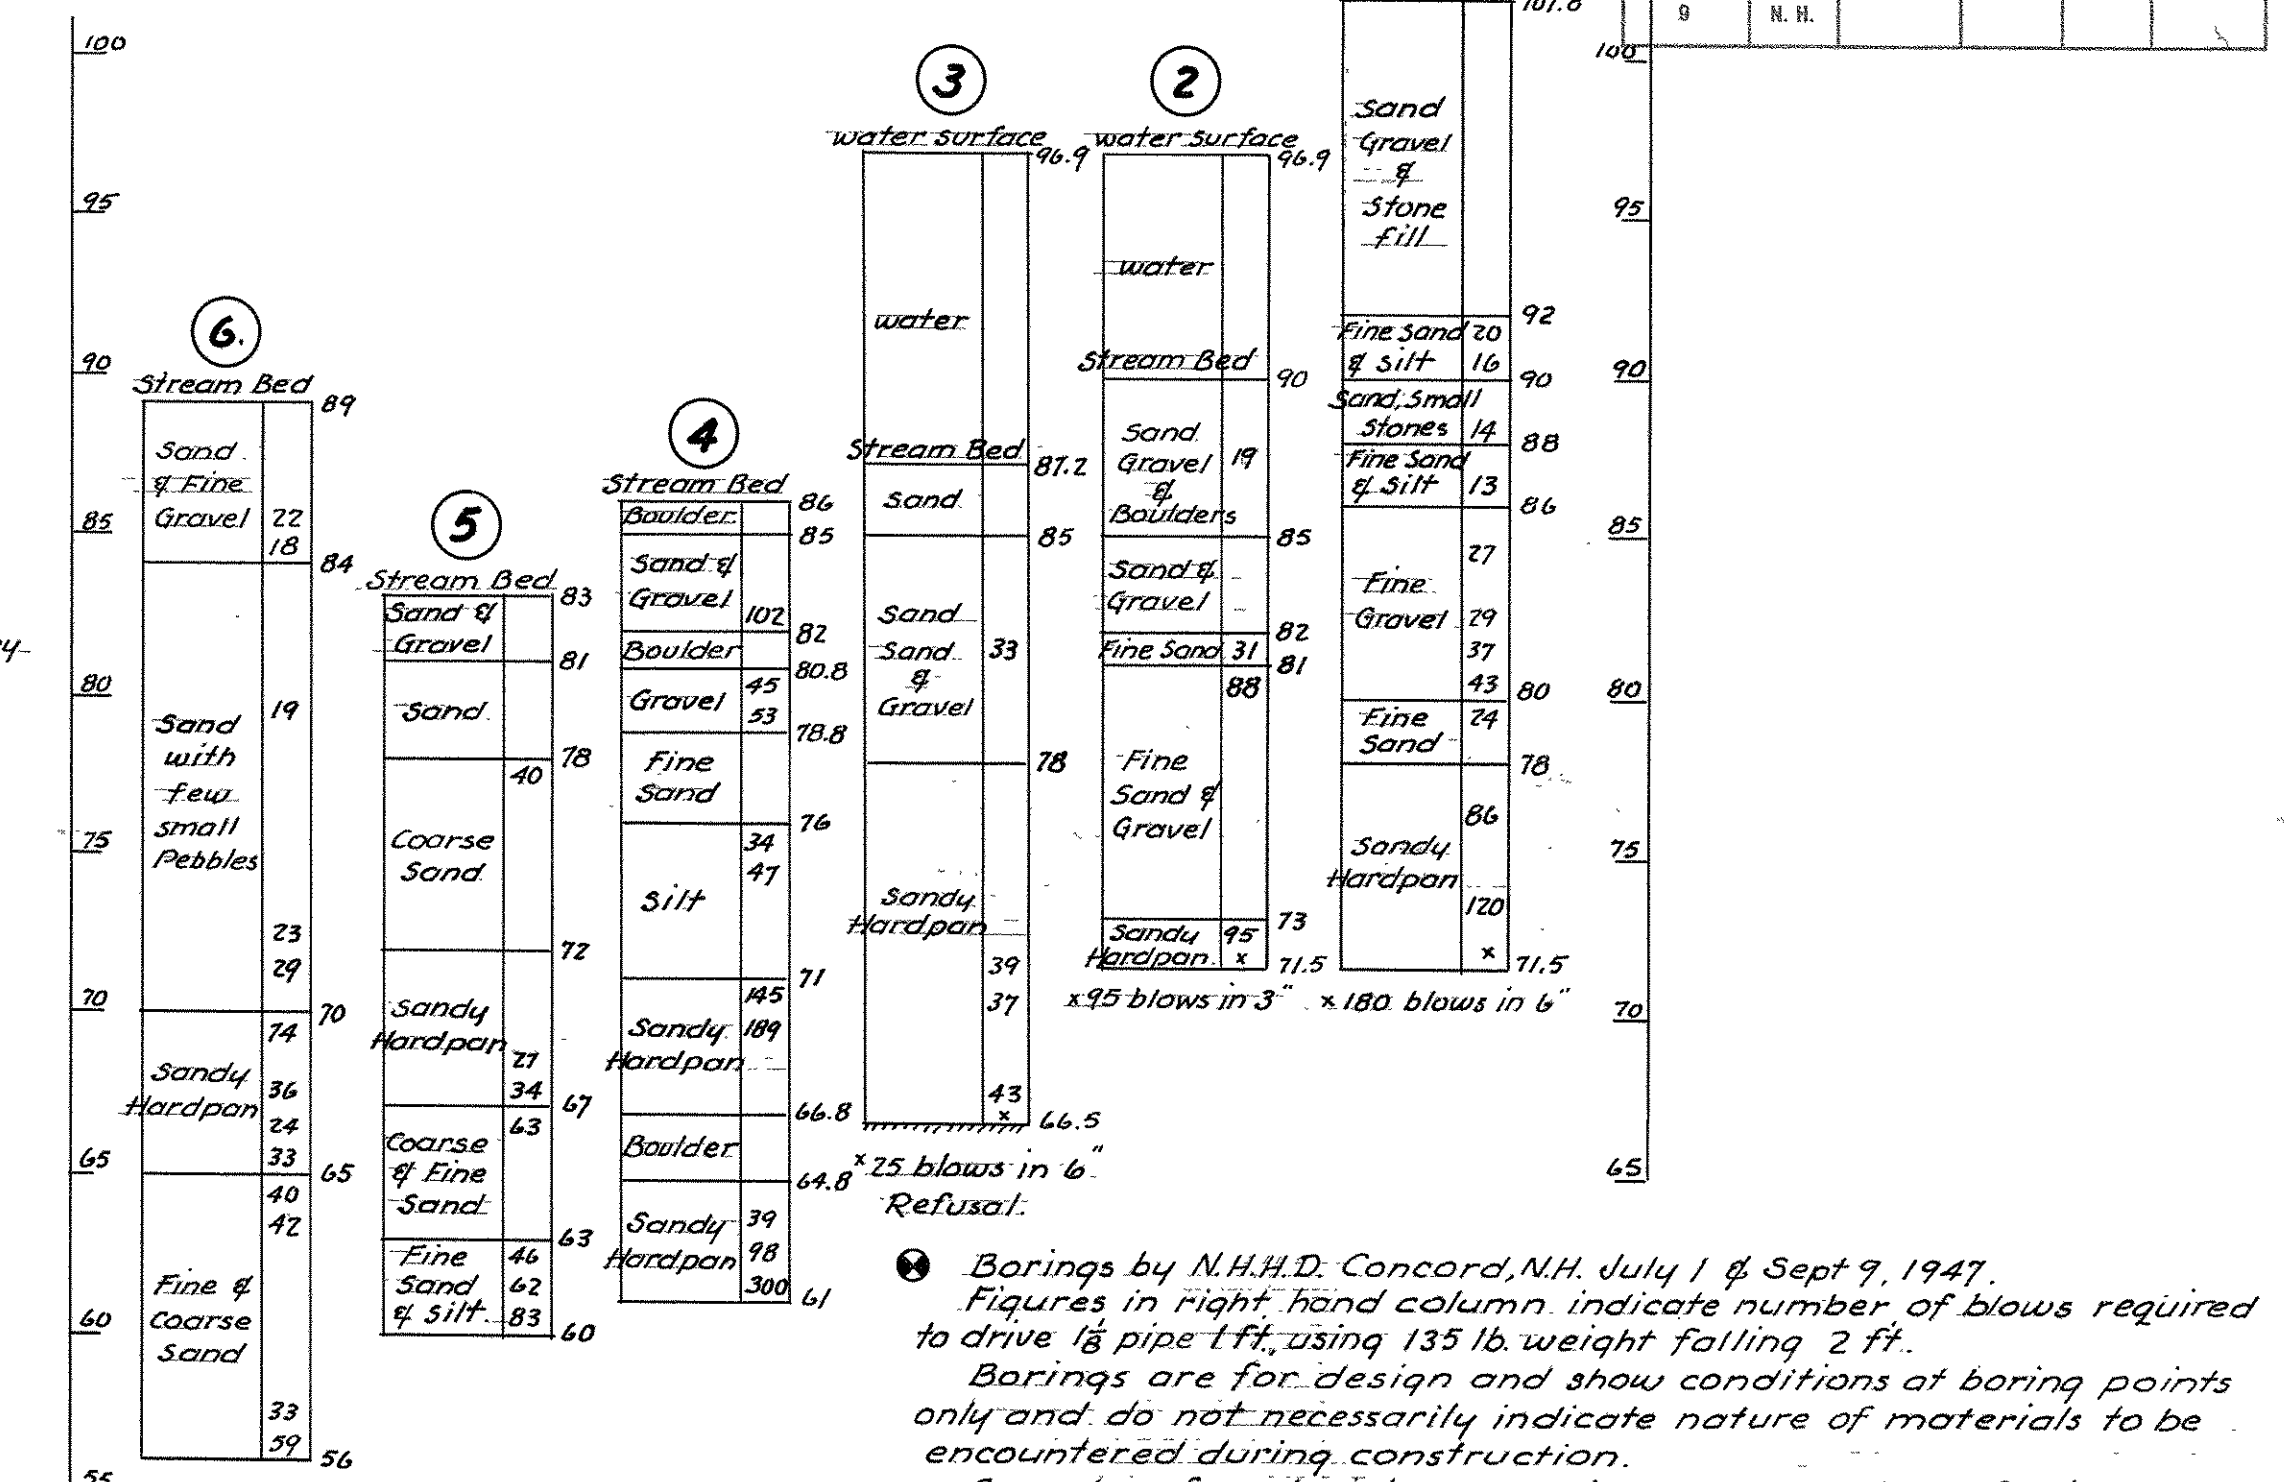
Borings by N.H.D. Concord, N.H. July 1 & Sept 9, 1947. Figures in right hand column indicate number of blows required to drive 18" pipe 1 ft, using 135 lb weight falling 2 ft. Borings are for design and show conditions at boring points only and do not necessarily indicate nature of materials to be encountered during construction. Samples of materials encountered are available for inspection at the office of the Bridge Engineer, Concord, N.H.

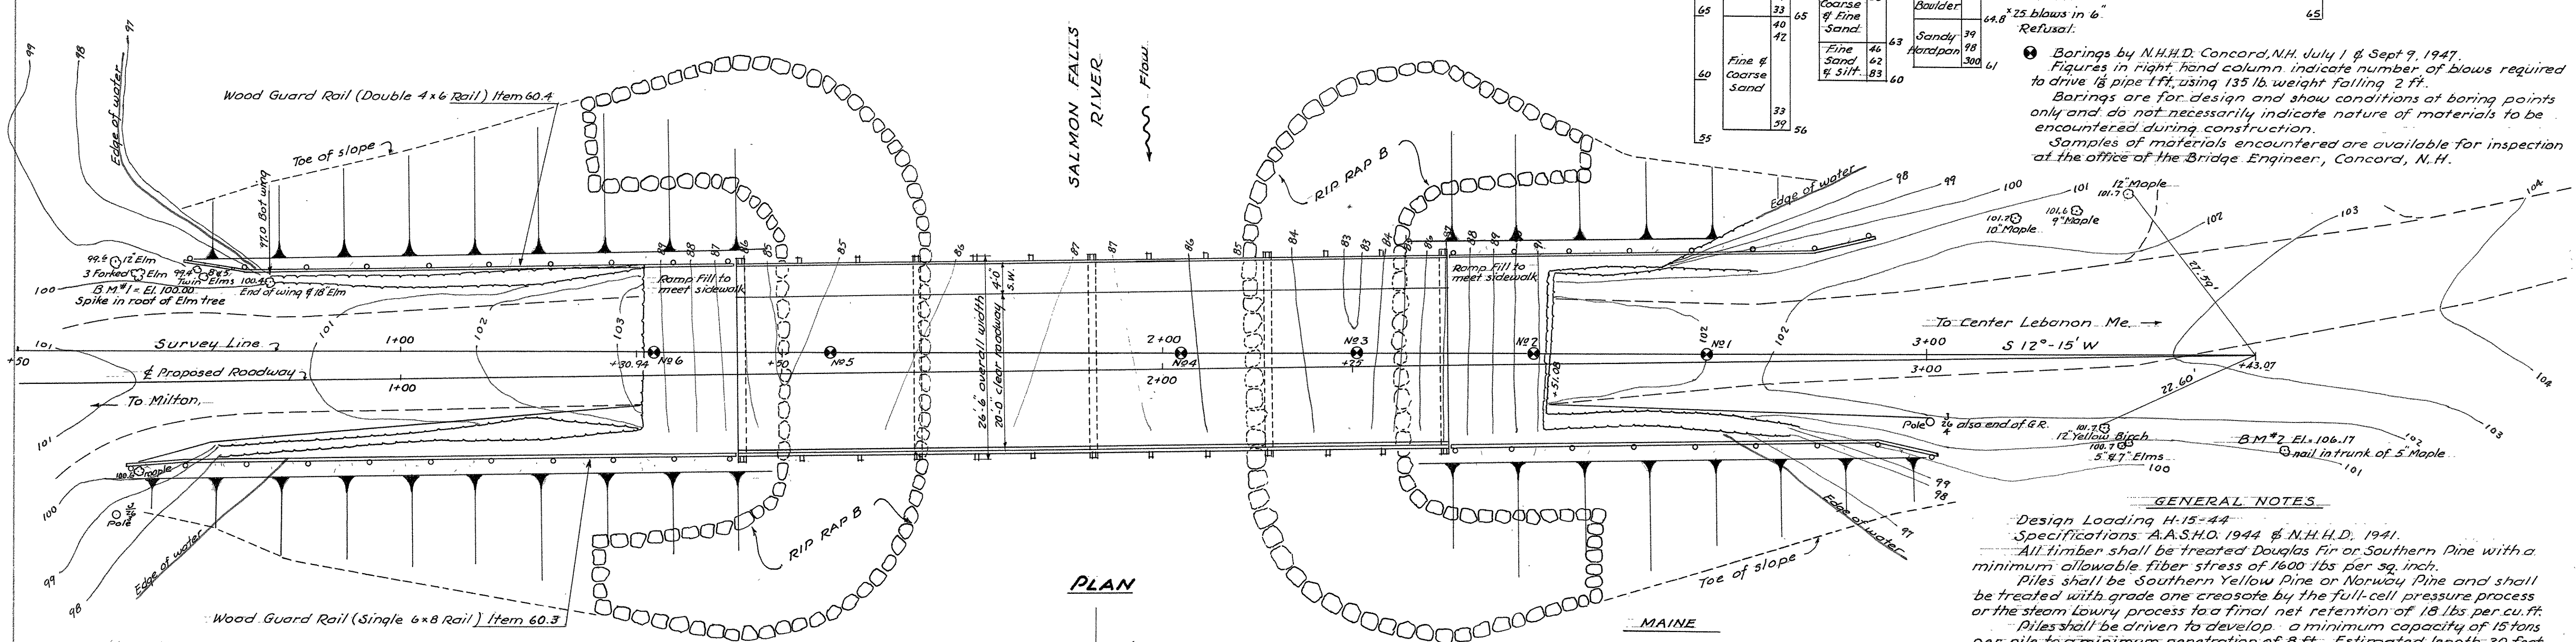
PLAN

The pre-existing bridge at the project location was jointly owned by the towns of Milton, NH and Lebanon, ME, and was constructed in 1948. The structure consisted of a Timber Beam-Stringer construction, resting on timber piles and timber abutments. The structure had an out-to-out span length of ~94' with a rail-to-rail width of 24'-0". The bridge remained open until 2010 when it was closed due to maintenance concerns and in 2013 the deck and superstructure were removed. The pier elements were removed in 2015. The only existing element remaining today is the timber abutments. The condition of the existing abutments was documented in an August 2021

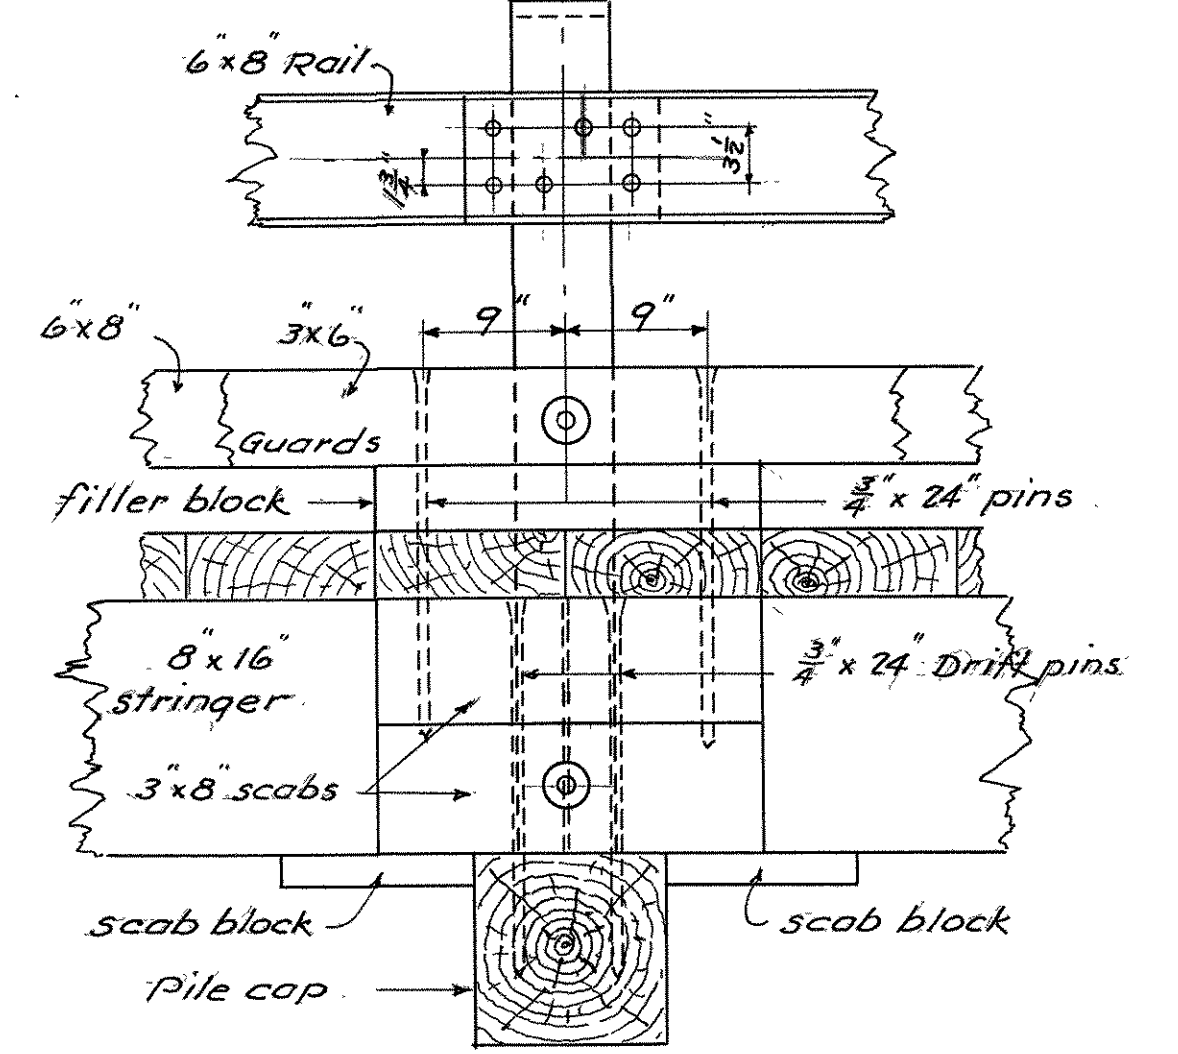
SECTION E-E
Scale 1" = 1'-0"

NOTE: Use 3" dia. malleable washers under all 3/8" bolt heads & nuts. Also lock washers under all nuts.

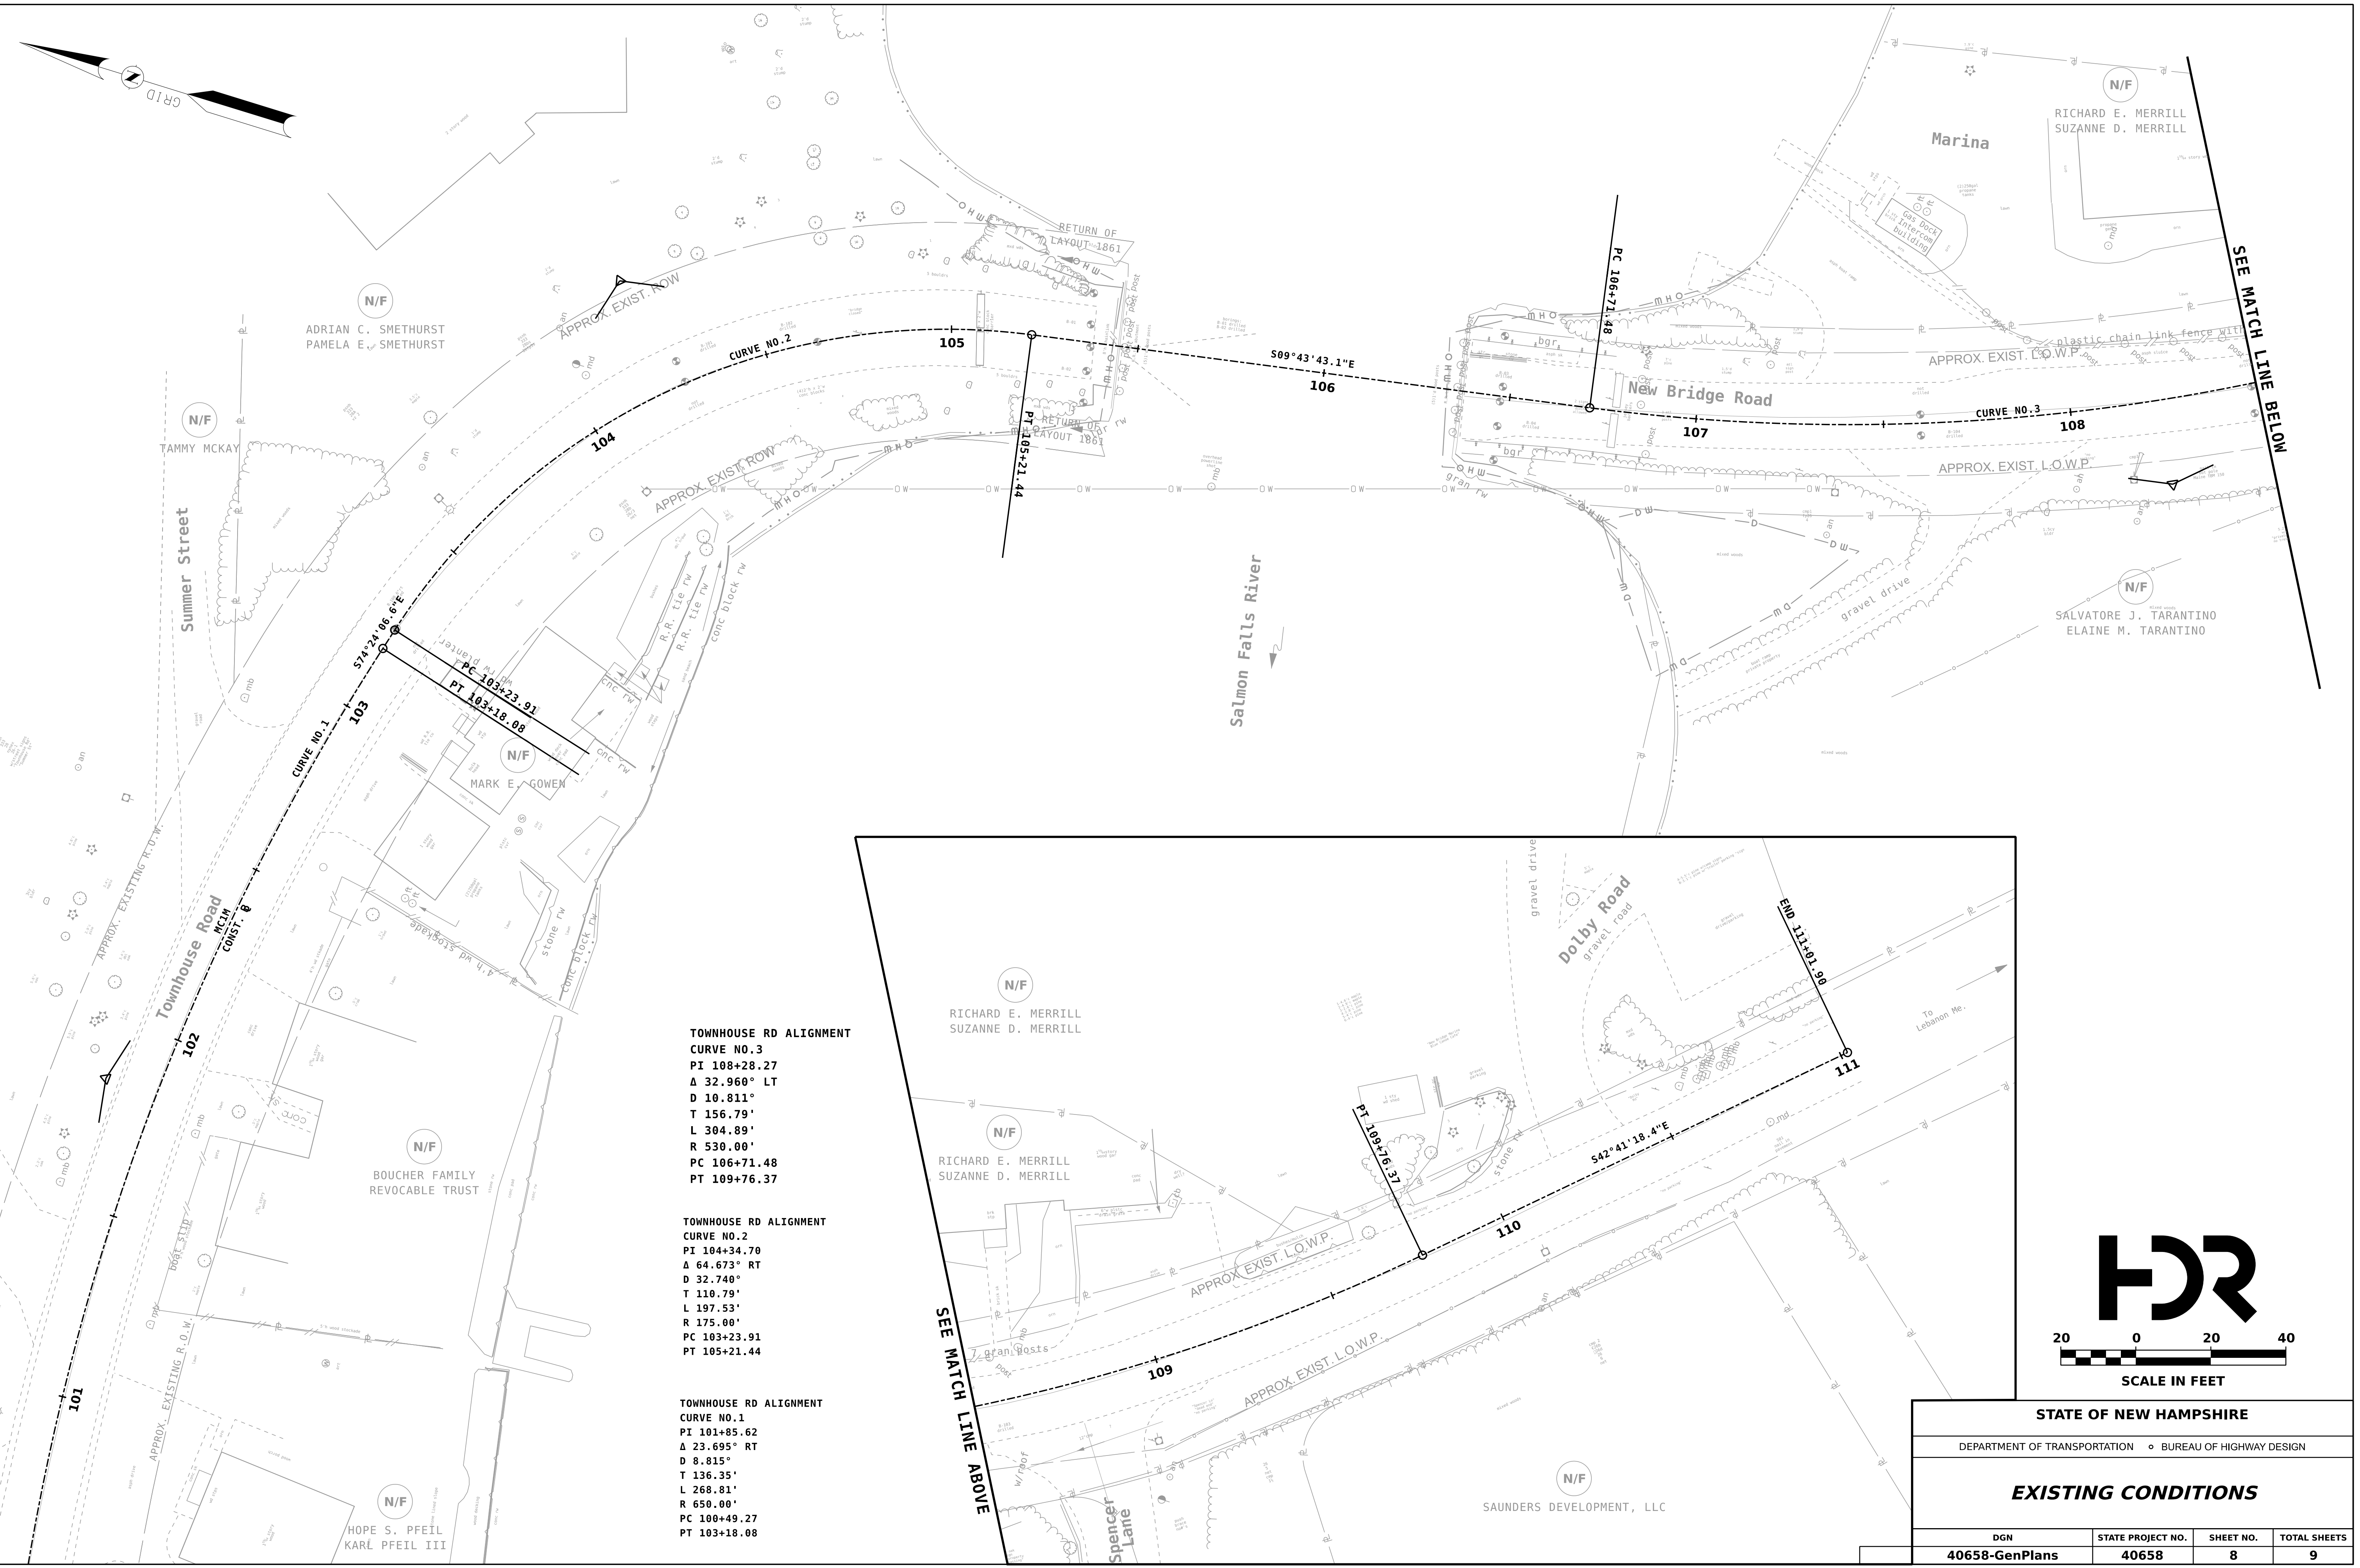
TOWNHOUSE RD ALIGNMENT
CURVE NO. 3
 PI 108+28.27
 Δ 32.960° LT
 D 10.811'
 T 156.79'
 L 304.89'
 R 530.00'
 PC 106+71.48
 PT 109+76.37

TOWNHOUSE RD ALIGNMENT
CURVE NO. 2
 PI 104+34.70
 Δ 64.673° RT
 D 32.740'
 T 118.79'
 L 197.53'
 R 175.00'
 PC 103+23.91
 PT 105+21.44

TOWNHOUSE RD ALIGNMENT
CURVE NO. 1
 PI 101+85.62
 Δ 23.695° RT
 D 8.815'
 T 136.35'
 L 268.81'
 R 650.00'
 PC 100+49.27
 PT 103+18.08

The proposed horizontal roadway alignment matches the existing alignment. As horizontal curve #2 will match existing conditions and not meet current AASHTO minimum radius design criteria for the design speed, a design exception will be required. Several vertical alignments were developed to meet the proposed geometric constraints listed above and are dependent on the bridge superstructure option. The vertical alignments are described in more detail with each alternative below.

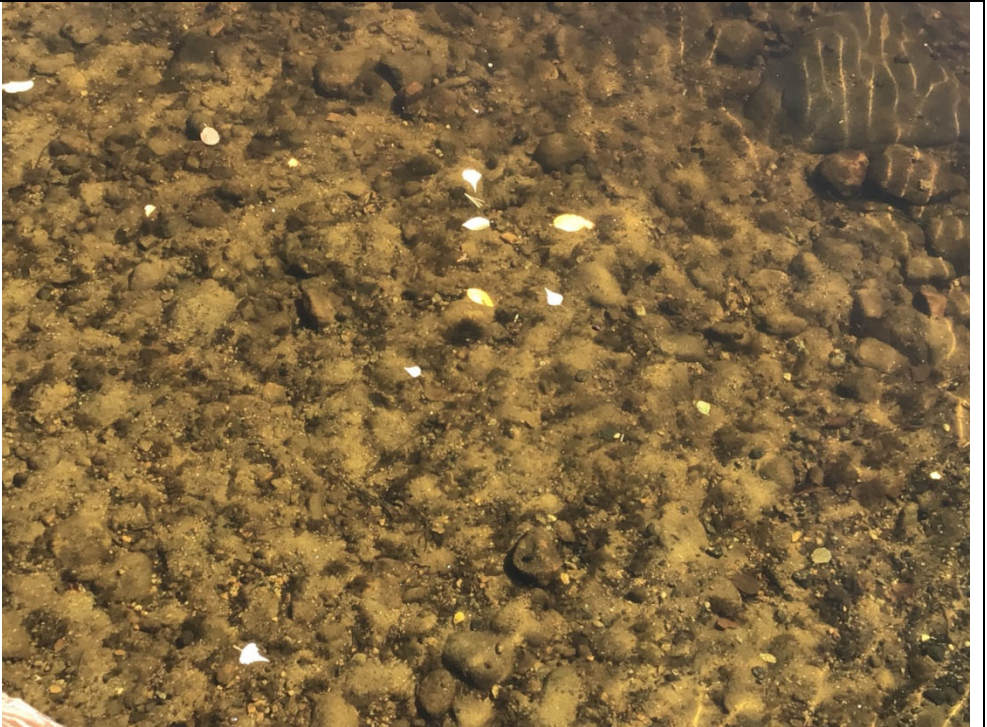
Photo No. 3	Date: 9/29/2022

Direction Photo Taken: N/A		
Description: View of aquatic substrate adjacent to existing bridge abutment in New Hampshire.
